Site/Project Location: Spread 7-8 Morton & Dunn Counties

Date of Inspection: 21 October 2016

Inspected Spread 7-8 of pipeline ROW approximately starting near Fort Rice, North Dakota and concluding near Zap, North Dakota.

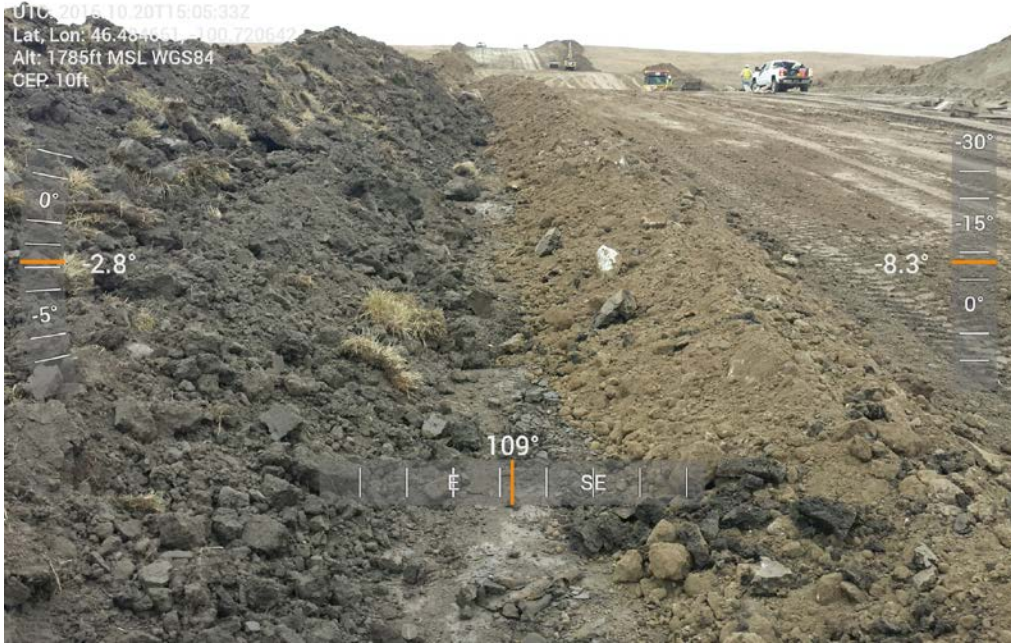
Report Photo #1 Subsoil and Topsoil Segregation

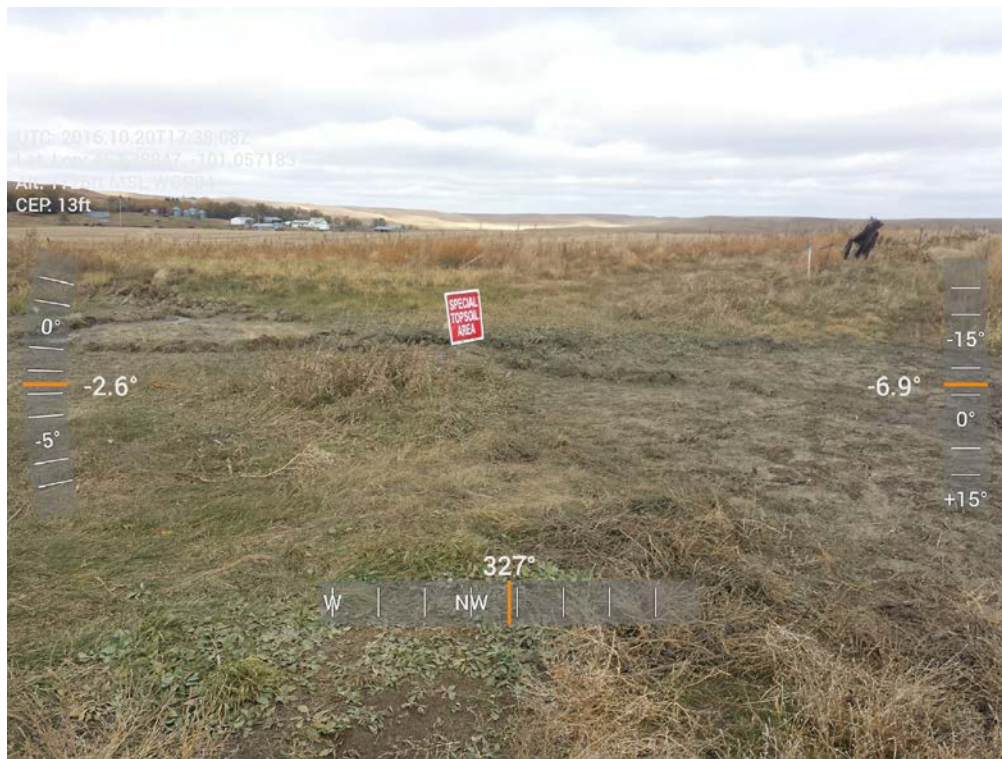
Report Photo #2 Sodic Soils Area

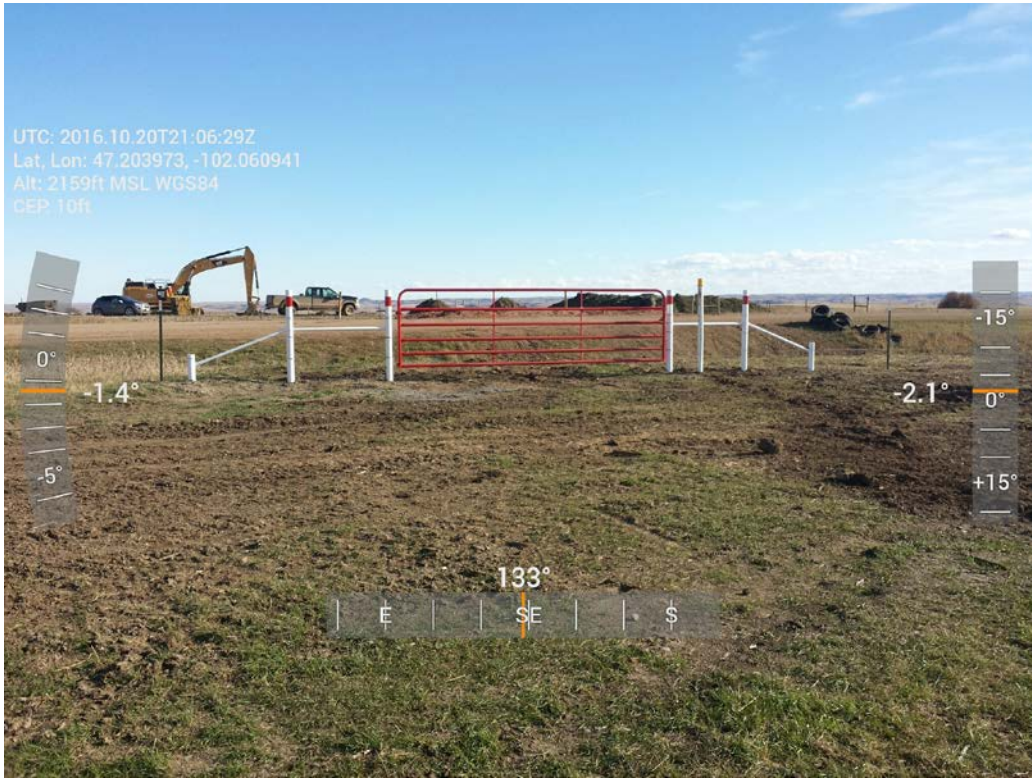
Report Photo #3 Permanent Gates Being Installed

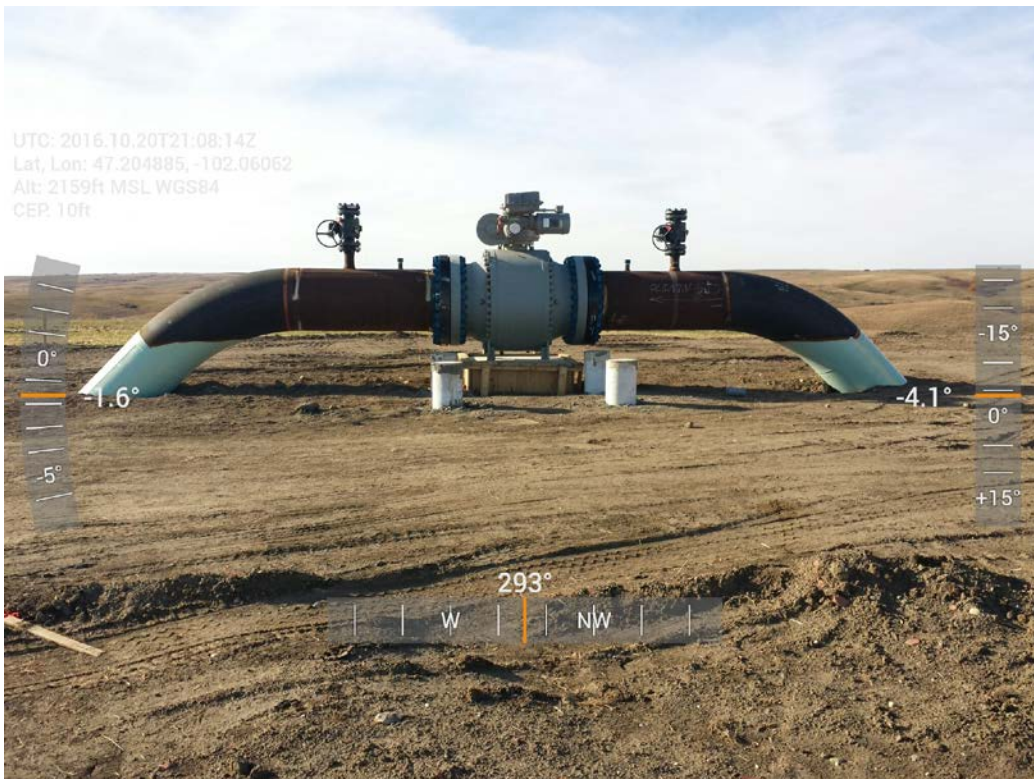
Report Photo #4 Valve Being Installed

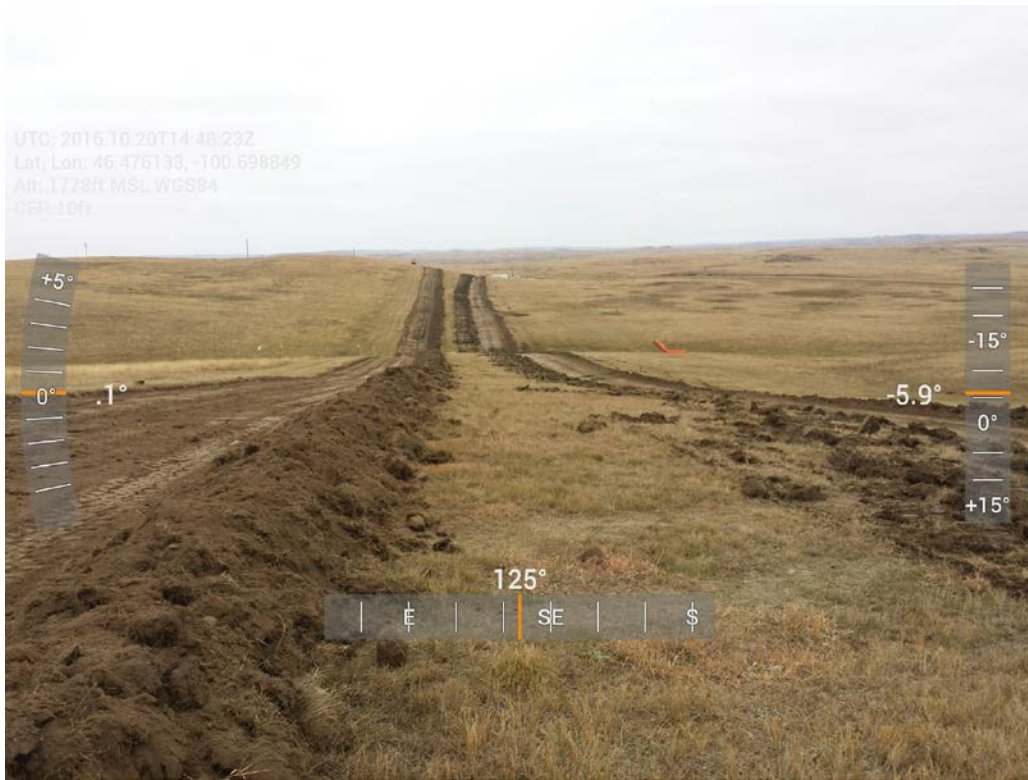
Report Photo #5 Topsoil Stripping

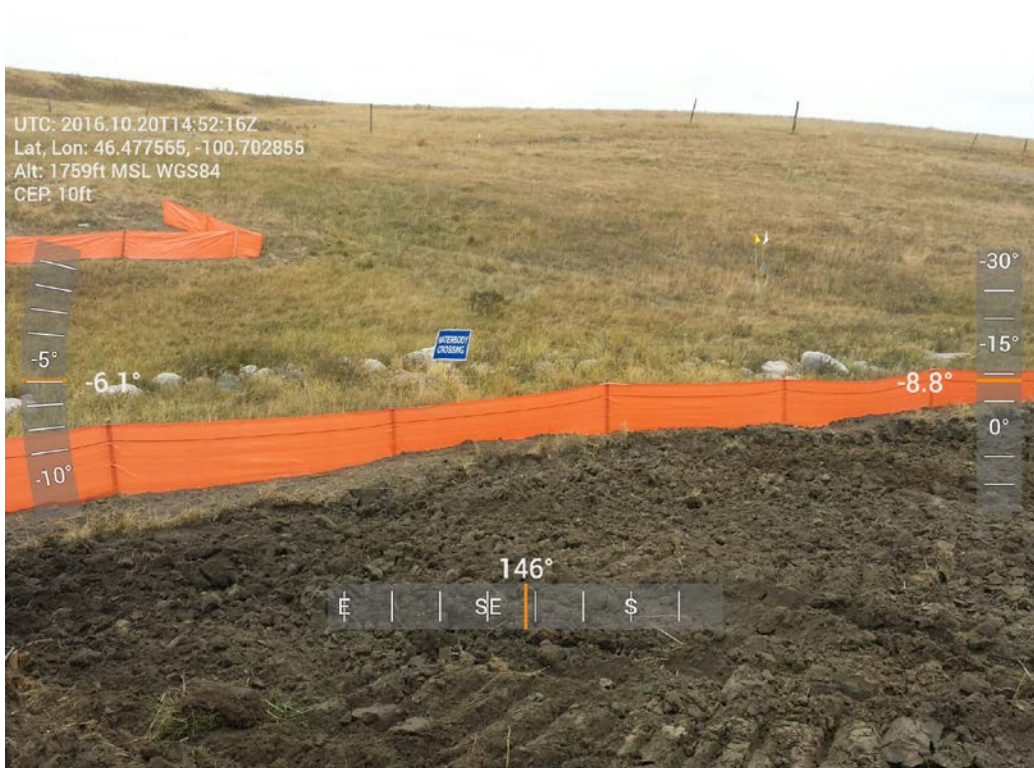
Report Photo #6 Waterbody Crossing

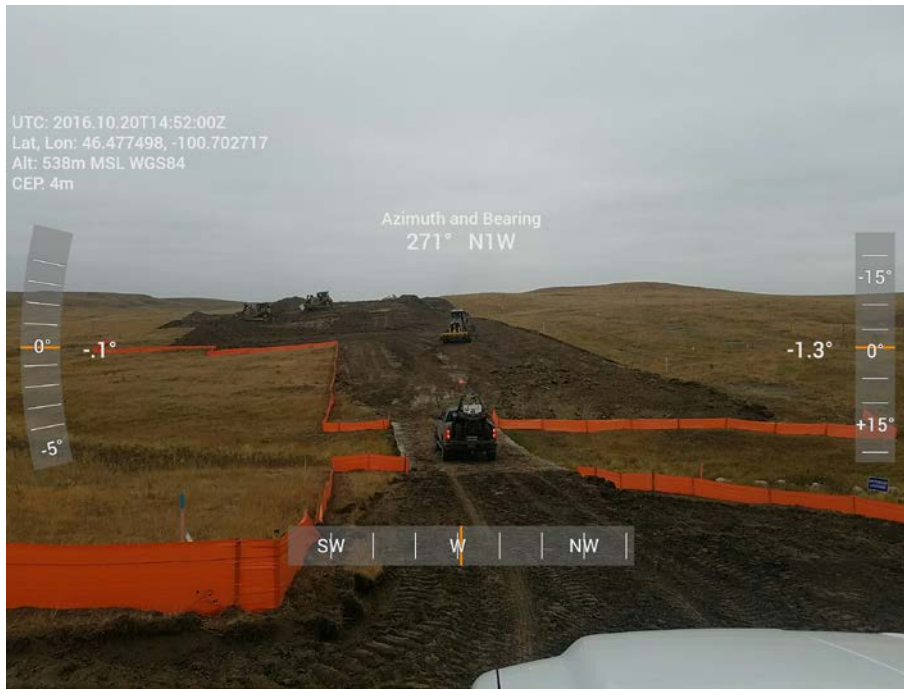
Report Photo #7 BMPs along Wetland
